Manhole Inspection Summary

Manhole # S67K__013MH

Insp Date: 1/11/08 10:09 AM

Location Address: **610 Falcroft St.**

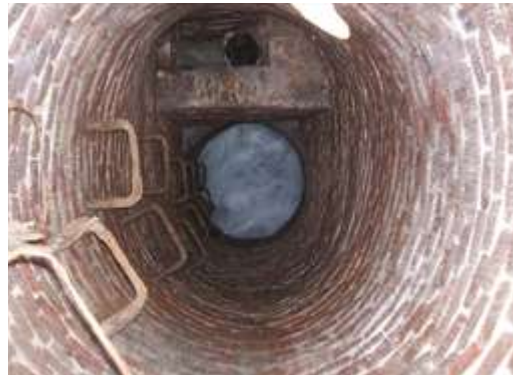
Top View

Condition: ☐ Sound ☒ **Cracked** ☐ Leaks

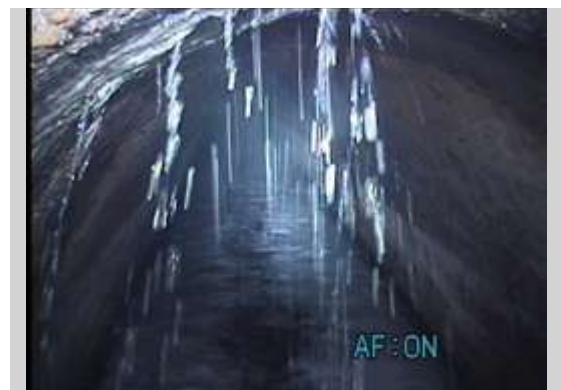
48.0 in. (w) x 66 in. (h) Oval Gravity Sewer
Pipe Out @ 12 O'Clock

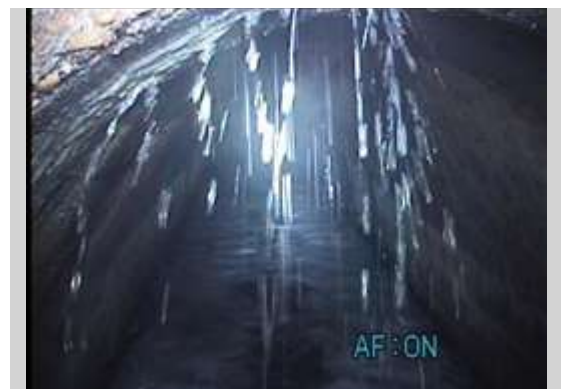
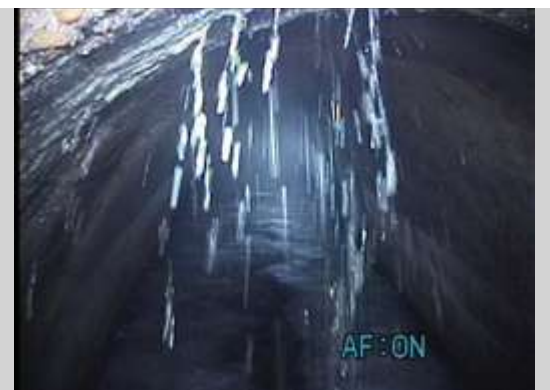
12 O'Clock Outflow
Pipe Out @ 12 O'Clock

Water in photo from drop line at I-11.

Pipe Height: **66** (in.) Rod and Bar (Angled)
Pipe Material: **Concrete** ☐ Pipe Lined
Invert Depth: **23.50** (ft.) Flow Characteristics: **Fast**
Deposits: ☒ None ☐ Mud ☐ Sludge ☐ Debris ☐ Grease
Silt Depth: (in.) Deposits Extent:
Infiltration: **None** Pipe Seal Cond: **Sound**

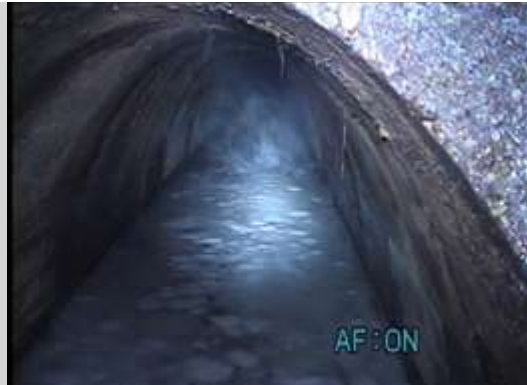
Pipe In @ 6 O'Clock

66 in. Circular Gravity Sewer

6 O'Clock Inflow

Infiltration: **None**

Pipe Seal Cond: **Sound**

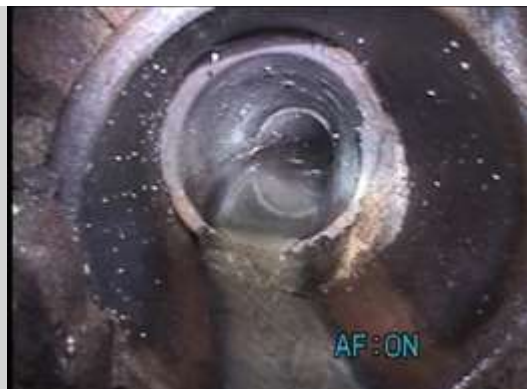
Drop In @ 11 O'Clock

10 in. Circular Gravity Sewer

11 O'Clock Inflow

Line not in GIS.

Drop: **Inside** Rod and Bar
Angled: **Yes** Reading: **17.00** (ft.)
Inv Depth: **18.00** (ft.)
Drop Condition: **Open**
